Case Study: Klipsch HQ – Home Theater Demo Room

Treatment Overview

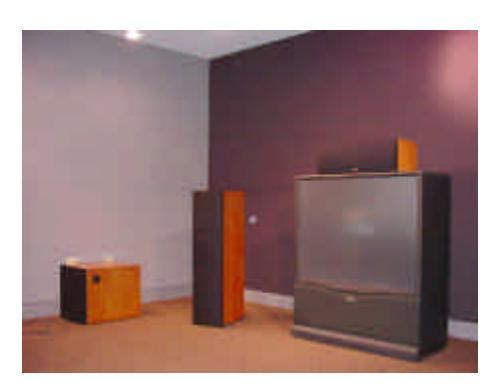
Figure 2 – EliTETM Wall Treatments

<u>Figure 2</u> shows the room finished with the *ELiTE* treatments on the walls.¹ The fabric finish of *ELiTE* met the aesthetic requirements for the room. The use of the 1" *ELITE* absorption material and the 1" *ELITE* diffusors provided excellent control of mid and high range sound above roughly 500 Hz.

¹ Reflections from the ceiling were tamed using non-Auralex acoustical diffusors.

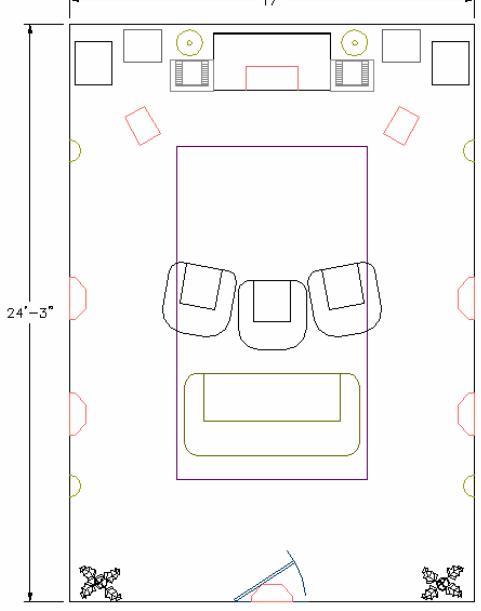
Figure 1 - Plan View of Home Theater

A plan and layout of the room is shown in <u>Figure 1</u>. Pre-treatment testing and observation revealed many acoustical problems. Among them:

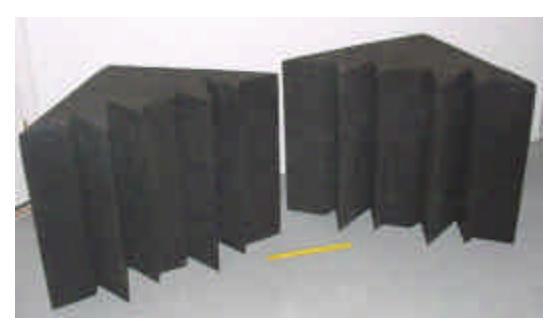
Figure 3 – MegaLENRDsTM

Placing the *MegaLENRDs* (Figure 3) in the corners tamed the low frequency problems to a very high degree. By adding twelve *MegaLENRDs* – three in each vertical corner of the room – the bass was much more defined and "smooth."

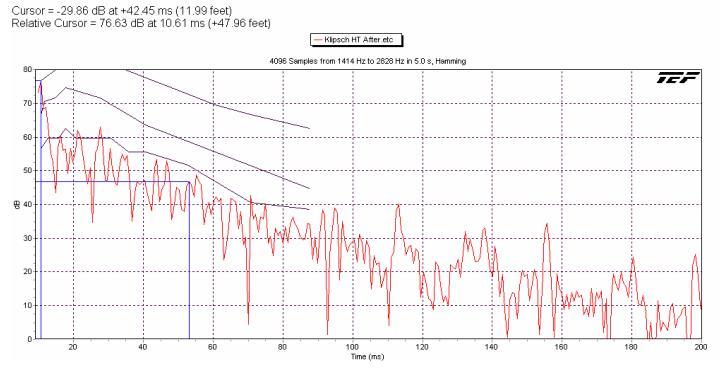
HT Room 2000 Klipsch HT Room 10/30/2002 9:38:26 AM

<u>Figure 5</u> shows the time response after *ELiTE* treatments are completely installed. Note the reduction of early reflections. The cursor has been placed at the same arrival time as <u>Figure 4</u> for easy cross-reference. The listening experience post-treatment is free of any distracting acoustical anomalies.

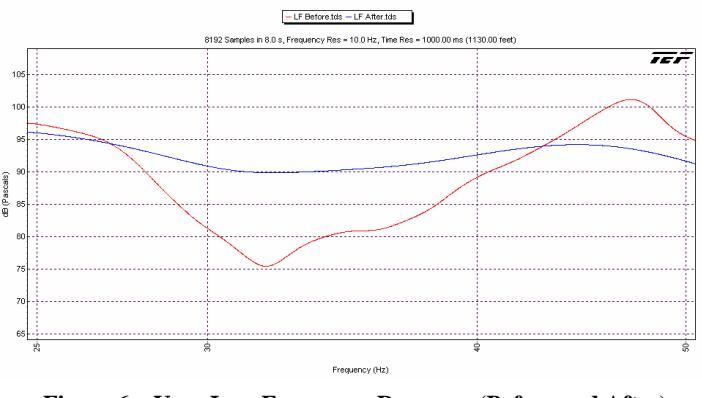
Figure 6 - Very Low Frequency Response (Before and After)

Low Frequency Results: Figure 6 shows very low frequency measurements at the listening position from 20 to 50 Hz – a major concern for *Klipsch* engineers evaluating subwoofer performance. The red "Before" curve shows the effects of an untreated room – a modal unevenness. The low frequency response is much smoother after the addition of all twelve *MegaLENRDs* shown by the blue curve. This provides the listener with a "tight," less "muddy" bass – an environment where a subwoofer can be evaluated. This is the low frequency equivalent of "removing" the room from the listening experience. While some may be skeptical of the effects foam "traps" can have at low frequencies, the testing in the *Klipsch* Home Theater Demo Room have shown that they can be quite effective indeed!
